# **Influence of Damage and Degradation on Breakdown Voltage of NM Cables**

## **Final Report**

Fan He, PhD, and Paul W. Brazis Jr., PhD

28 January 2013

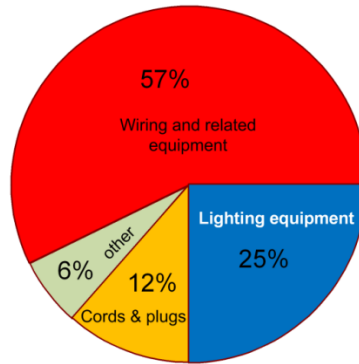
Figure 1 - Source of electrical fires

According to published reports and research articles, the number of residential electrical fires ranges from 28,300 to 60,000 per year<sup>5</sup>, depending on the source of the data. Since the terms ‘electrical fire’, ‘electrical wiring’, and ‘electrical equipment’ are not rigorously defined in literature, quantitative data varies among sources. Approximately half of all electrical fires can be attributed to installed wiring and related equipment<sup>6</sup>. Figure 1 shows the reported sources of electrical fires.

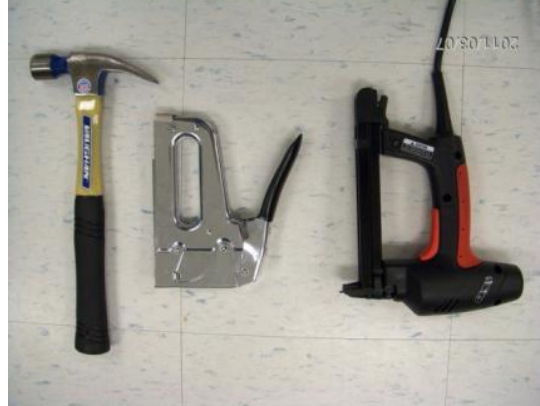
Figure 2 - NM cable installation tools

applied force of the NM cable installation tools, there is a potential of damage to the NM cable during a home installation. According to the inspection reports<sup>22,23</sup>, the most common types of cable damage include cable puncture, cable over-compression and hammer impact. Electrical Code inspection organizations record many NM cable installation code violations every year, but there are few quantitative reports which provide details of how likely the NM cable can be damaged during installation, and what level of damage the NM cable may suffer.

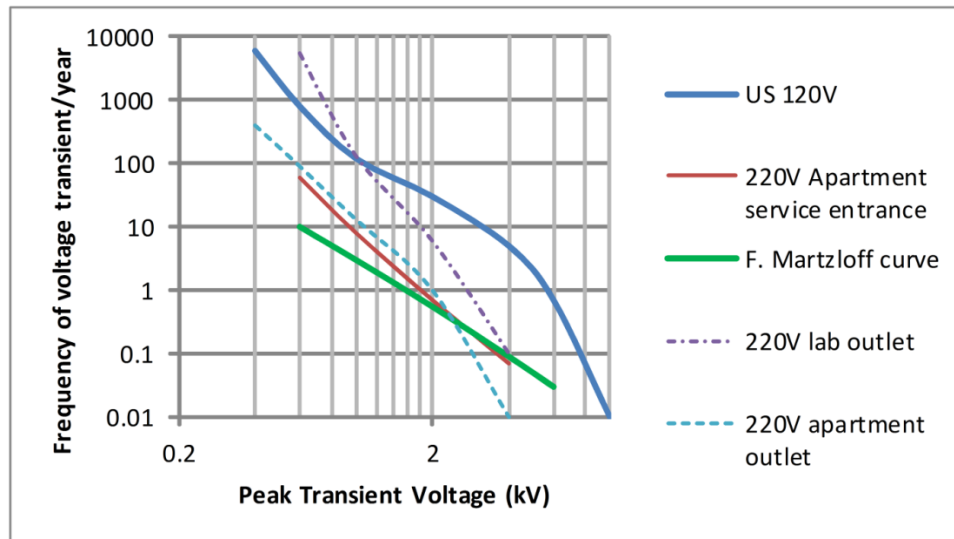
Figure 3 - Residential voltage surge statistics.<sup>15</sup>

Francois Martzloff investigated residential voltage surges in the 1960s and his research work is still used as an important reference for expected surge voltages for residential electricity distribution system design and test. Figure 3 shows frequency data on voltage surges from Francois Martzloff and other sources<sup>15</sup>.

According to the data, the probability of 6 kV and higher voltage surge is relatively low in the residential electricity distribution system, with less than one surge event greater than 6kV expected per year. This coincides with requirements in electrical wiring test standards for the dielectric breakdown voltage for home electrical wiring insulation materials. It may be observed from the figure that the frequency of voltage surge in the USA (blue line in Figure 3) of 2 kV is 15 per year and surges of 1 kV are more than 100 per year.

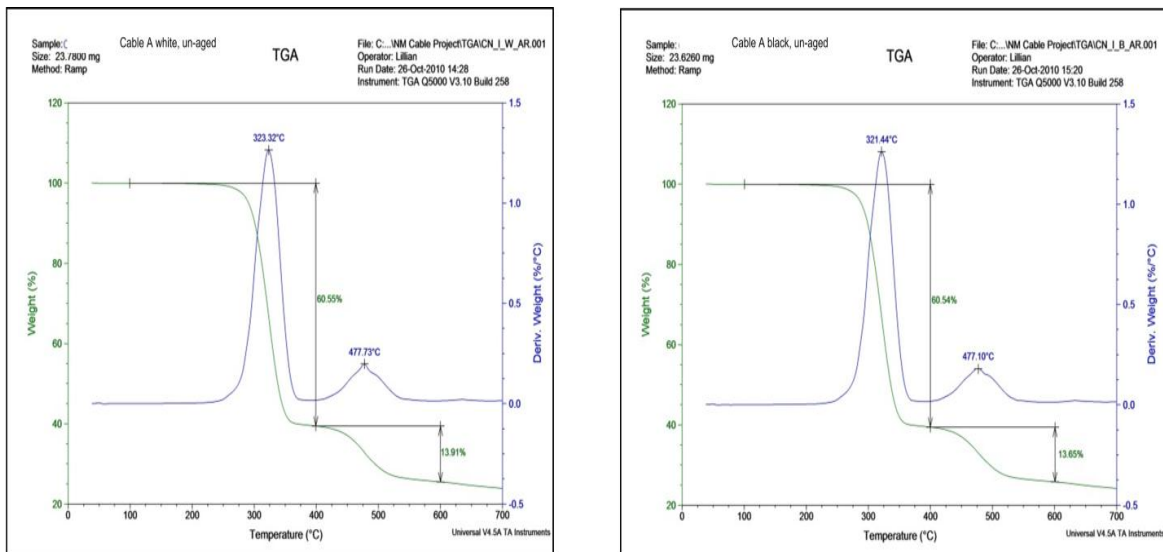
Figure 4 - TGA from Cable A Insulation

In the temperature scan mode, the TGA furnace temperature is increased at a constant rate in air or nitrogen environment, and the insulation sample weight is monitored. Figure 4 through Figure 8 show the TGA weight loss rate results in air environment and at 20 °C/min scan rate for ten different NM cable insulation materials from the five NM cable samples. The results for white insulation material are on the left hand side, and results for the black insulation are on the right hand side.

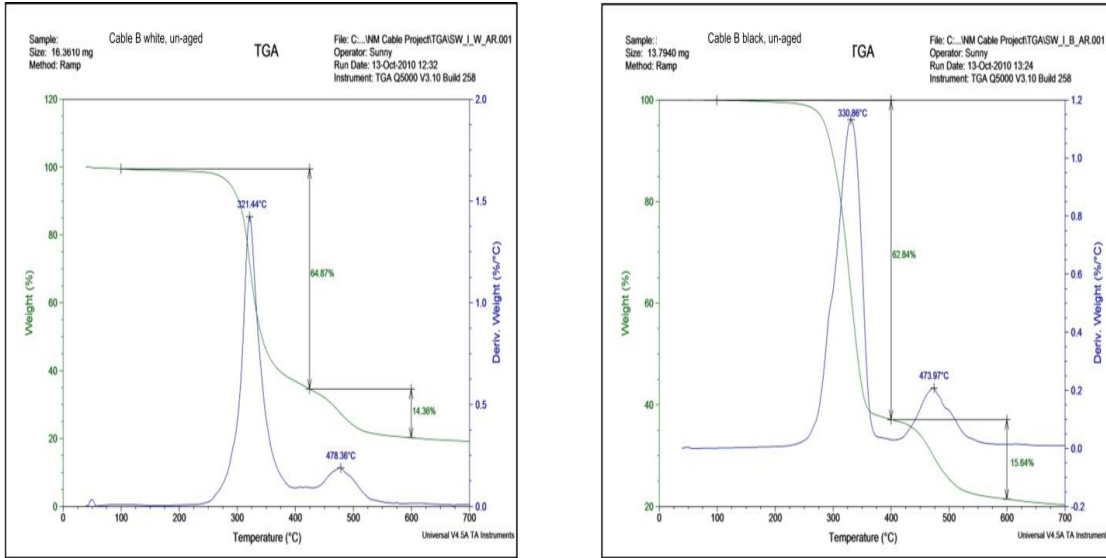
Figure 5 - TGA from Cable B Insulation

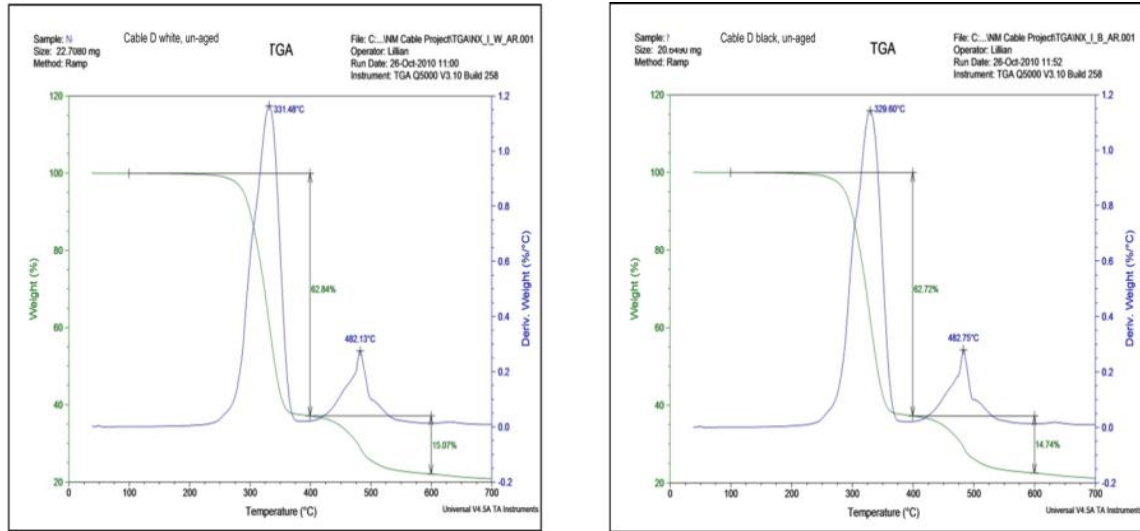
Figure 7 - TGA from Cable D Insulation

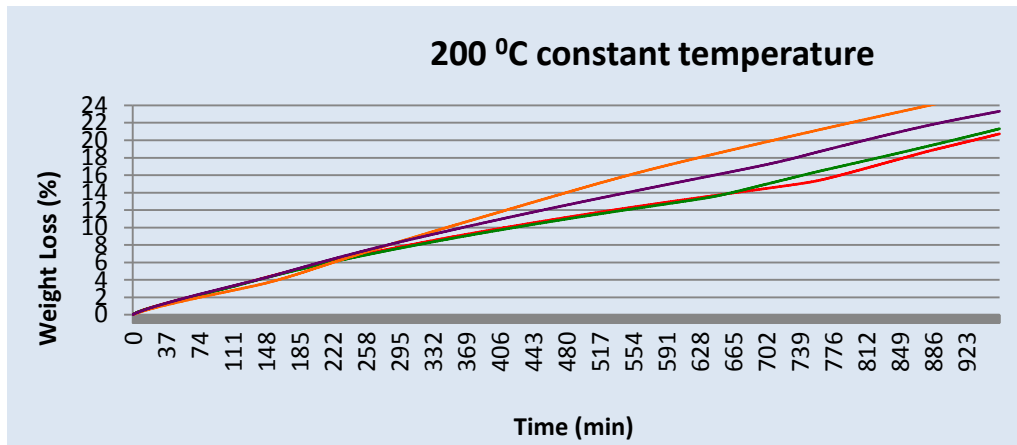
Figure 9 - Constant temperature TGA data. The red trace is cable B white insulation weight loss, the green trace is cable B black insulation weight loss, the purple trace is cable E black insulation weight loss, and the orange trace is cable E white insulation weight loss.

Figure 9 depicts weight loss of four different insulation materials. The chart shows that the insulation material weight loss is a nonlinear function of time, and insulation materials from different brands of NM cable have different weight loss rates at a particular TGA temperature. The nonlinear characteristic observed in the weight loss data is indicative of multiple thermal decomposition processes in the insulation material

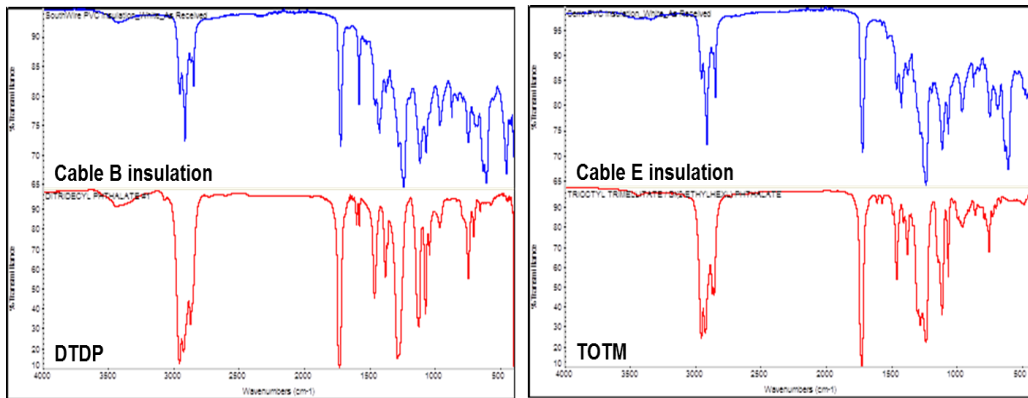
Figure 10 - FTIR spectrum for Cable B and Cable E insulation

Figure 10 shows the test results for Cable B and Cable E insulation (in blue) for the white insulation. The black insulation also has similar IR characteristics. The plasticizers used in the cables were identified through comparison to a chemical library (in red).<sup>18</sup> The FTIR results indicate that Cable B has a phthalate plasticizer, while Cable E has trimellitate plasticizer. These plasticizers exhibit significantly different properties as will be discussed in the following sections. The plasticizer data for each NM cable are summarized in Table 5.

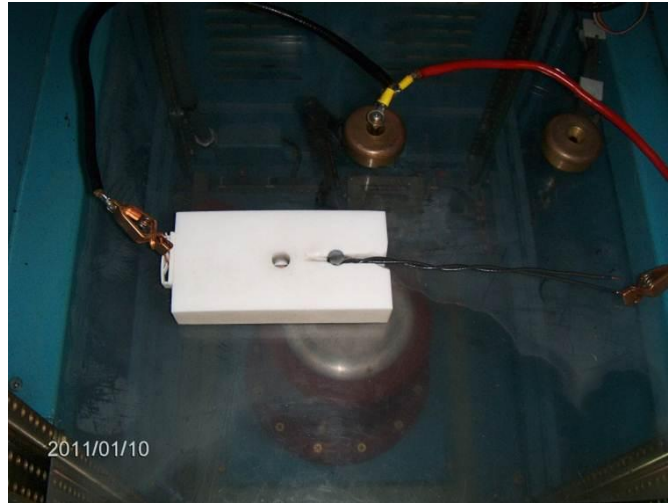
Figure 11 - Fixture for the NM cable breakdown voltage test

When performing breakdown voltage tests in air, it was observed that the air is ionized and generates a corona when the electric field strength is greater than the air breakdown threshold of 3 kV/mm. Since high speed particles in the corona can preheat the sample and weaken the wire insulation, it impacts the measurement of the breakdown voltage. Thus, the test fixture was redesigned to reduce the impact of the corona on the measurement, as it was anticipated that the breakdown voltage of the insulation materials to be greater than 3 kV. The test fixture is depicted in Figure 11. The test fixture was designed to test a single-insulation conductor (without the NM cable outer jacket).

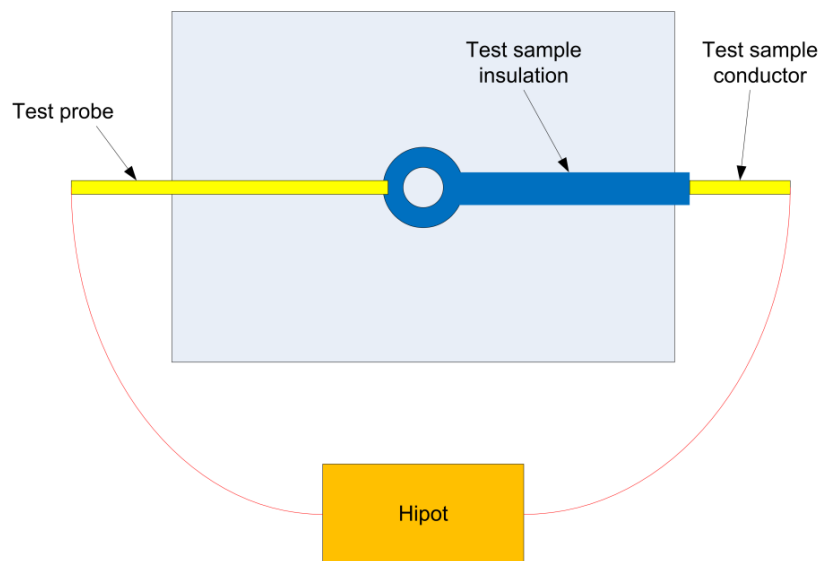
Figure 12 – Cross-section of the Teflon fixture for the NM cable breakdown voltage test

A schematic of the cable sample under test and the test probe during the breakdown voltage test is depicted in Figure 12.

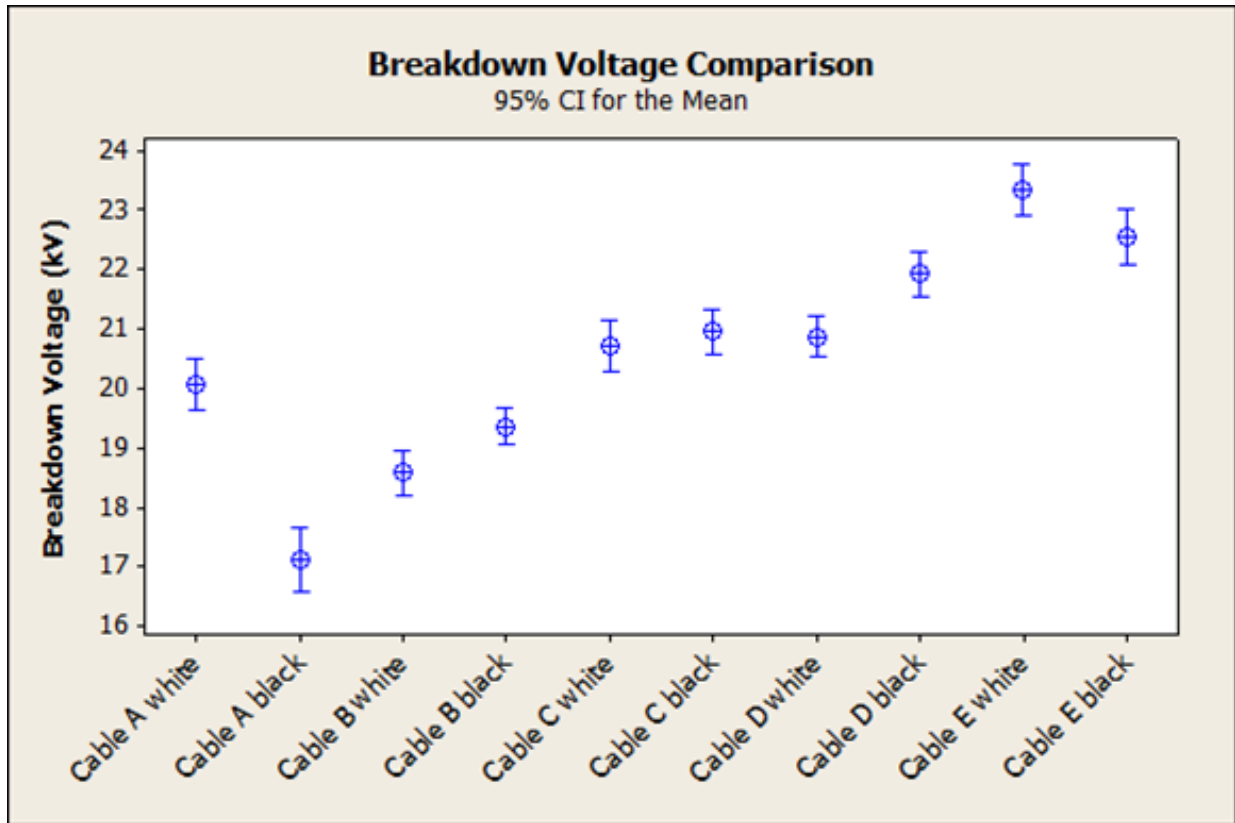
Figure 13 - Average breakdown voltage comparison

To develop statistically significant data, 30 specimens were tested on both the black and white insulation for each type of the NM cables, except for Cable C (29 white specimens and 29 black specimens). The average, minimum, and maximum values of the breakdown voltage are depicted in Figure 13.

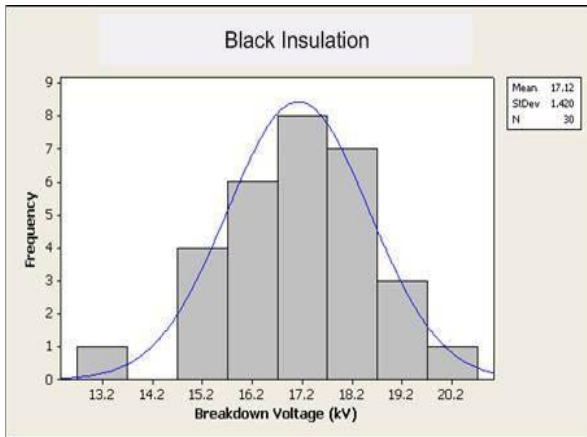
Figure 14 - Cable A breakdown voltage distribution

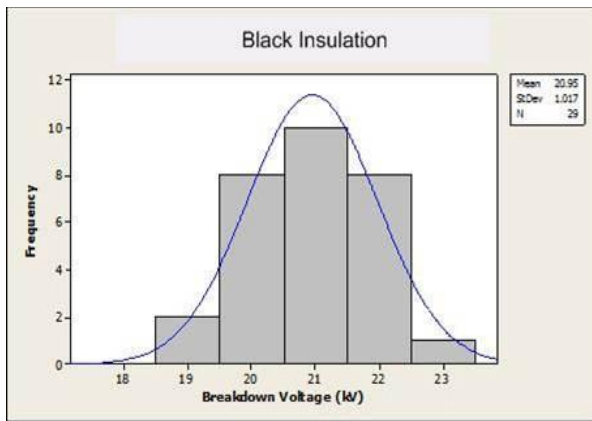
Figure 16 - Cable C breakdown voltage distribution

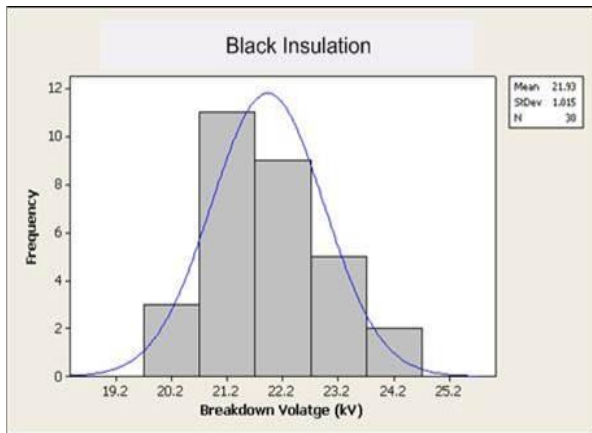
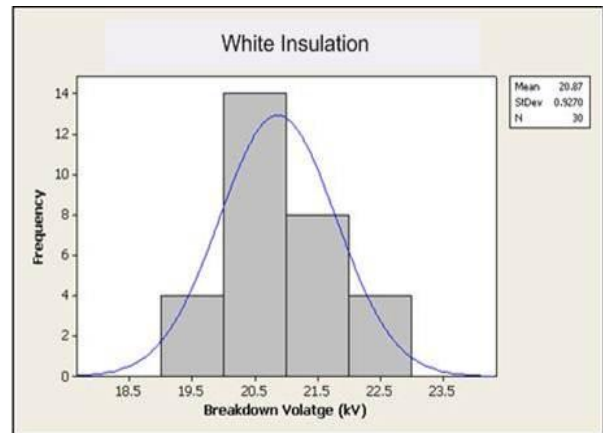
Figure 17 - Cable D breakdown voltage distribution

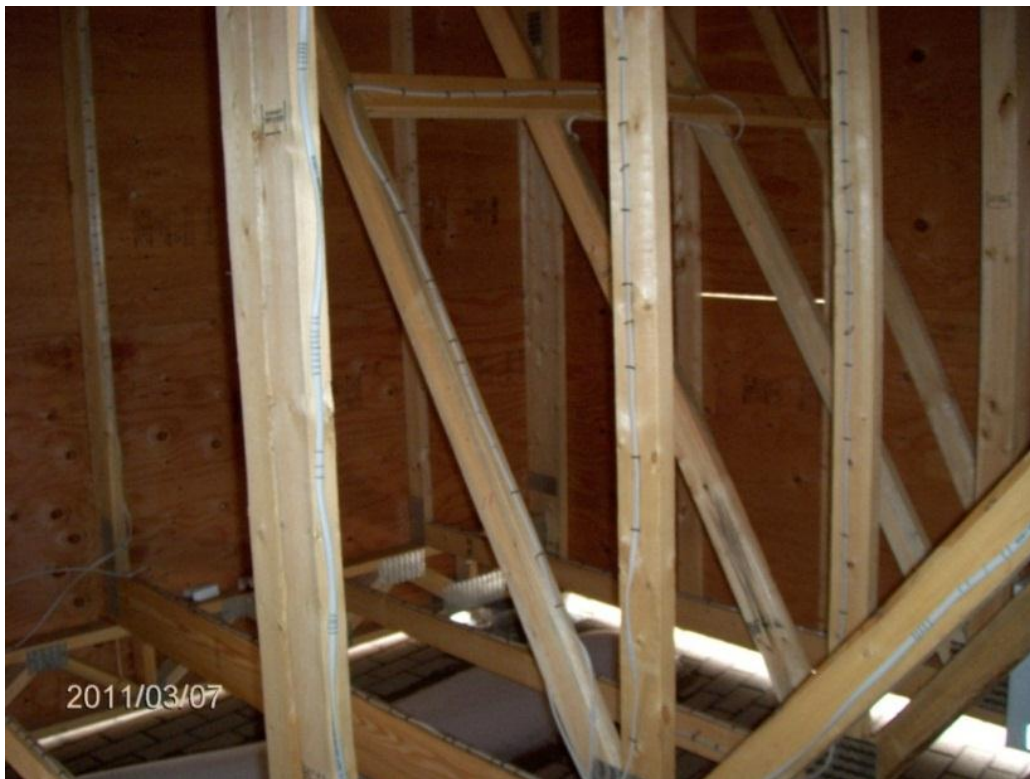
Figure 19 - NM cables installed on wood studs

A series of scoping tests were conducting using common installation methods to assess the nature and degree of possible damage to NM cable insulation. Cable segments were installed on wood studs using NEMA the guidelines for installing the cables.

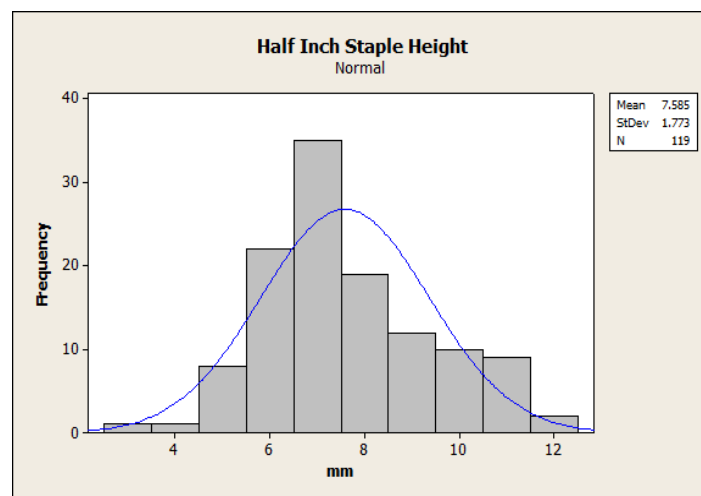
Figure 26 - Distribution of the distance between the top of the installed staple to the wood frame.

The measurements of the staple height,  $d$ , are presented in Table 13. The results were used to design a mechanical hammer simulator that provided a repeatable staple driving capability. The data indicate that the average distance between the top of the installed staple to the wood frame is 0.30 in. and the distribution is normal as shown in Figure 26.

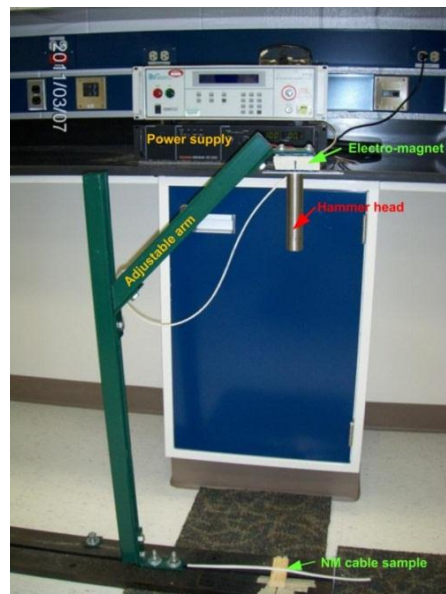
Figure 27 - Hammer impact simulator

With this procedure, it was found that a 7ft-lb force would provide the required staple depth with two hammer drops; and a 5 ft-lb force would result in the required depth in three hammer blows.

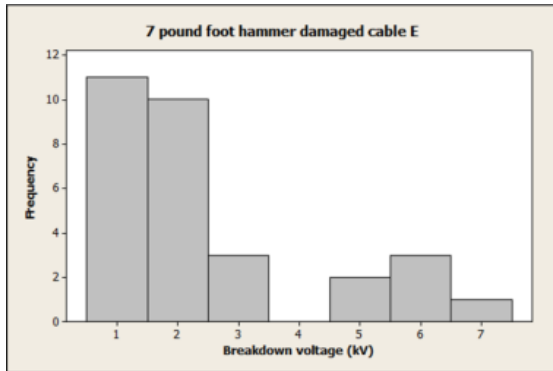
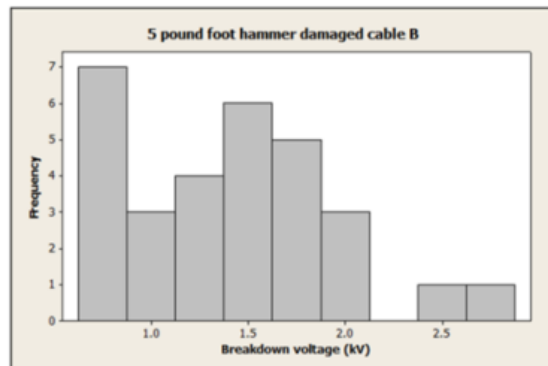
More than 90% of cable E samples with 7 pound foot hammer damage failed 6kV breakdown voltage test.

About 37% of cable E samples with 5 pound foot hammer damage failed 6kV breakdown voltage test.

Figure 32 - Breakdown voltage distribution of cable E damaged by hammer impact

100% of cable B samples with 7 pound foot hammer damage failed 6kV breakdown voltage test

100% of cable B samples with 5 pound foot hammer damage failed 6kV breakdown voltage test

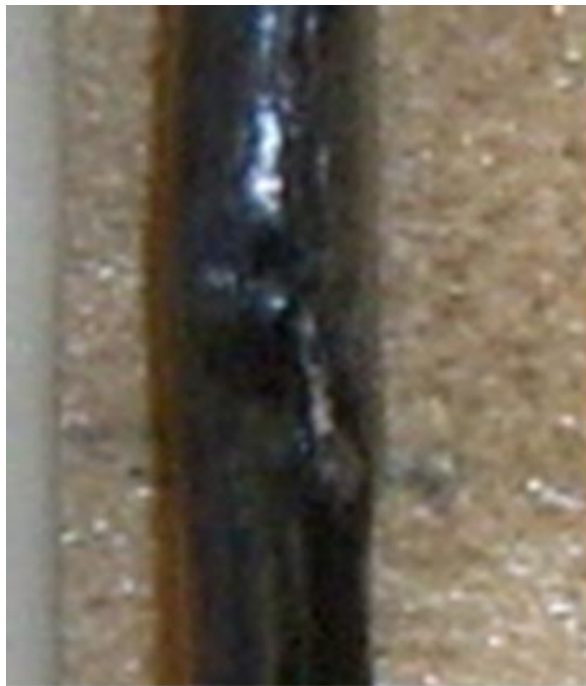
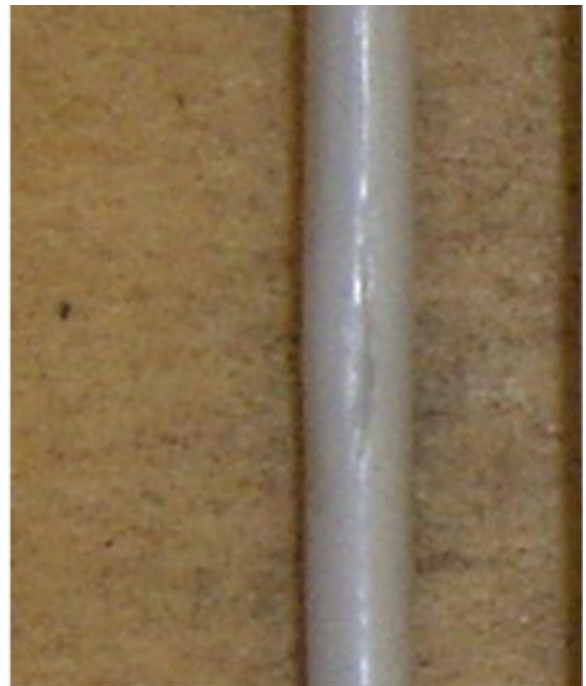
Figure 34 - NM Cable insulation cracked by 7ft-lb hammer impact

a hammer impact can result in the NM cable insulation dielectric strength to fall well below the 6 kV threshold value. In some cases, the 7 ft-lb hammer impact cracked the NM cable insulation, an example of this is shown in figure 34.

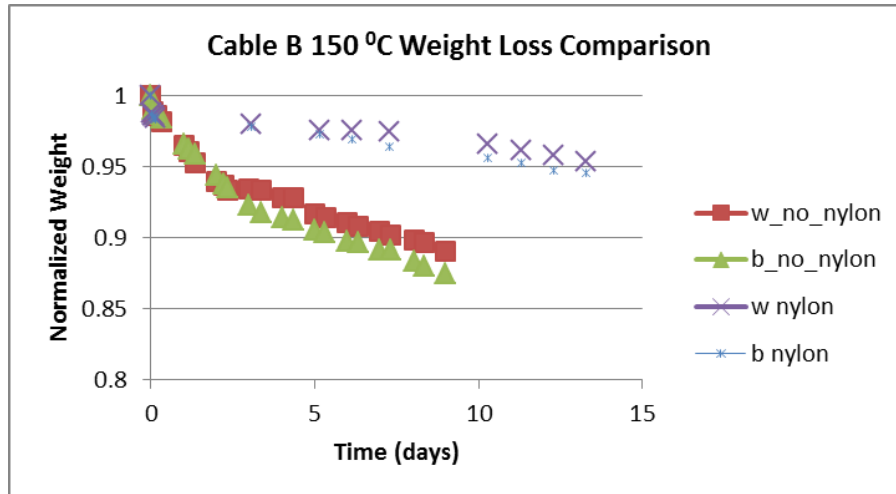
Figure 36 Comparison of Cable B insulation aging with and without nylon layer

For the measurement of insulation weight loss with the nylon layer, the sample preparation and measurement procedure are the same as that for the insulation without the nylon, except aging the NM cable insulation samples with the nylon intact. Figure 36 compares the measured weight loss of Cable B insulation with and without the nylon layer. The result shows that the nylon significantly retards weight loss.

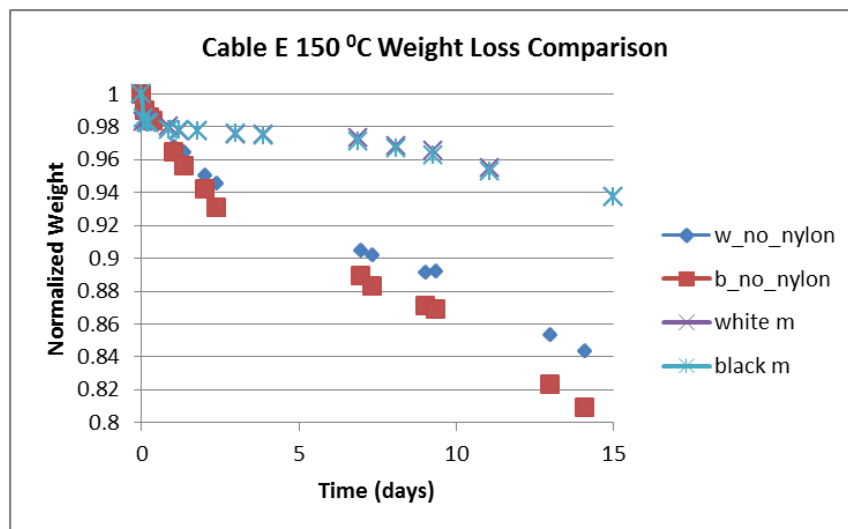
Figure 37– Comparison of Cable E insulation aging with and without nylon layer

Figure 37 shows a similar result for Cable E. The data indicate that the insulation weight loss occurs approximately twice as fast when the nylon coat is removed compared to when it is present.

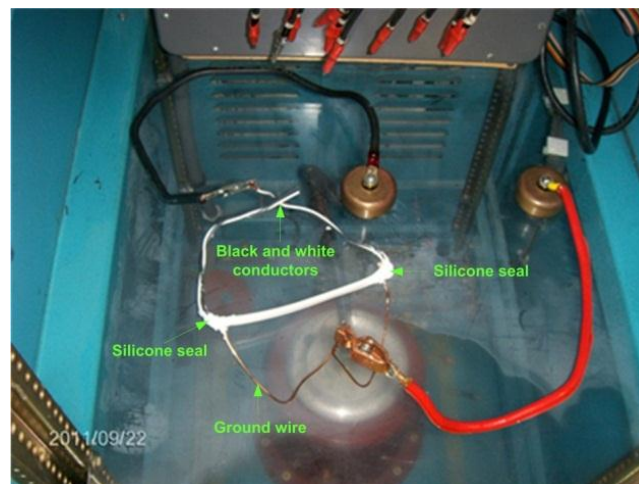
Figure 42 – Setup for the breakdown voltage test for intact NM Cable

Measuring the thermal aging impact to NM cable damaged through over-compression required the measurement of the breakdown voltage of the NM cable with its jacket intact. The challenge of testing the complete NM cable is that the corona formed at the test voltages above 3 kV may short the electrodes before insulation breakdown is achieved. To reduce the impact of the corona, a longer NM cable sample was used and the cable jacket opening was sealed with silicone based sealant. Figure 42 shows the prepared sample inside the chamber of the high-voltage tester.

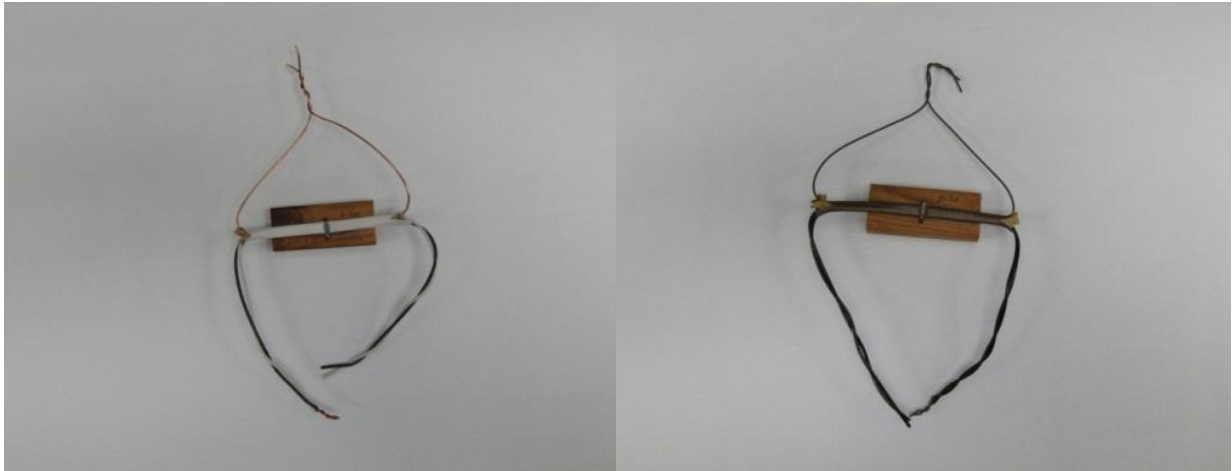
Figure 43 - Over-compressed NM cable B sample for breakdown test

The procedure to prepare the over-compressed and thermally aged sample is the same as above, but the samples were then aged in the thermal chamber at a constant temperature using the same method as described in Task 4. Figure 43 shows a prepared over-compressed sample. Figure 44 shows a prepared over-compressed sample that was subsequently aged at 150°C for three days.

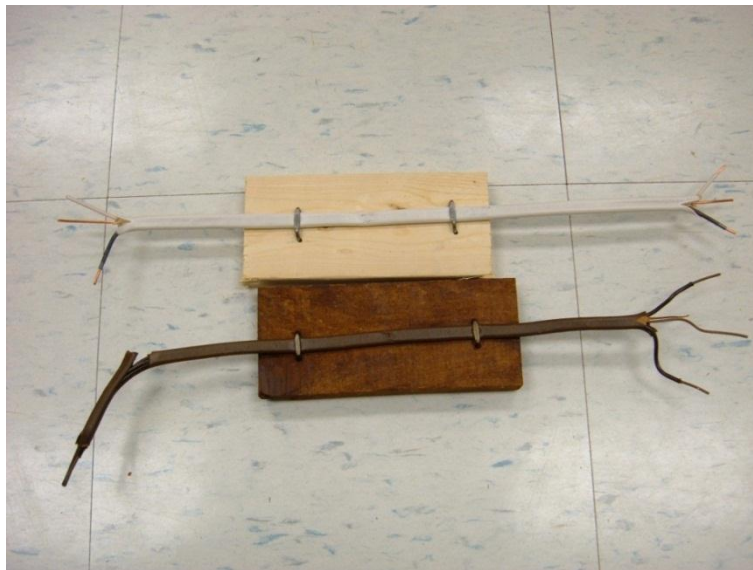
Figure 45 – Hammer-damaged and aged NM cable samples for the UL1449 test.

- Samples were cut to a length of about 18 inches.
- The sample is secured to a piece of pinewood with two metal staples.
- A test fixture is used to damage the NM cable by dropping a two-pound steel hammer head on the test sample from a height of 3.5 ft. This is the same method described in the prior hammer impact studies.
