TABLE SAW HAZARD STUDY ON FINGER INJURIES DUE TO BLADE CONTACT

JANUARY 2014

Table Saw Hazard Study on Finger Injuries Due to Blade Contact

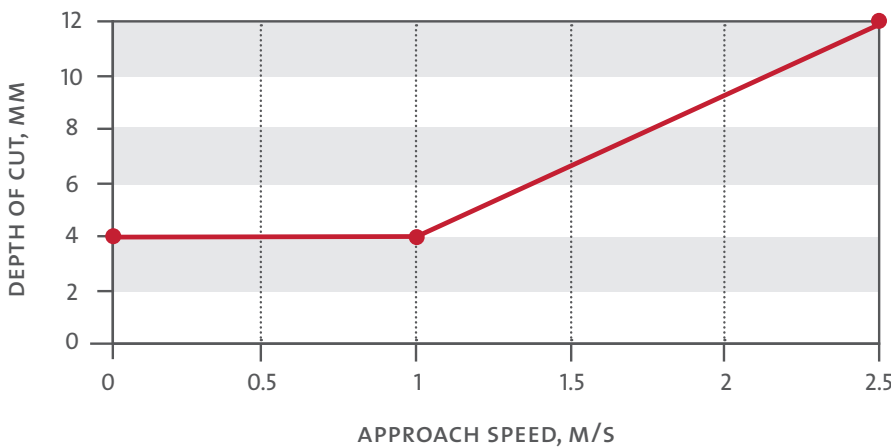
Figure 1: Recommended approach speed versus depth-of-cut relationship

- Finger contact with a table saw should not result in a depth of cut of more than 4 mm (0.157 inches) at any approach speeds equal to or less than 1 m/s (3.28 ft/s).
- The table saw should be tested at a lower approach speed to ensure that the performance of the safety technology does not degrade. This lower approach speed can be based on the operational details of the safety technology or else set to a value of 0.1 m/s (0.33 ft/s).
- In addition, the depth of cut should remain proportional to approach speeds beyond 1 m/s (3.28 ft/s). An upper approach speed limit of 2.5 m/s (8.2 ft/s) is recommended. Therefore, at this approach speed, the acceptable depth of cut should be 12 mm (0.47 inches) or less.¹

Note: The approach speed described above is the linear speed of a surrogate finger that is traveling parallel to the table saw surface toward the midpoint of the exposed portion of a blade set to a standard height.

Note: The depth of cut should be measured on a surrogate finger. The surrogate finger must possess the key properties that trigger the safety device and allow for repeatable depth-of-cut measurements.

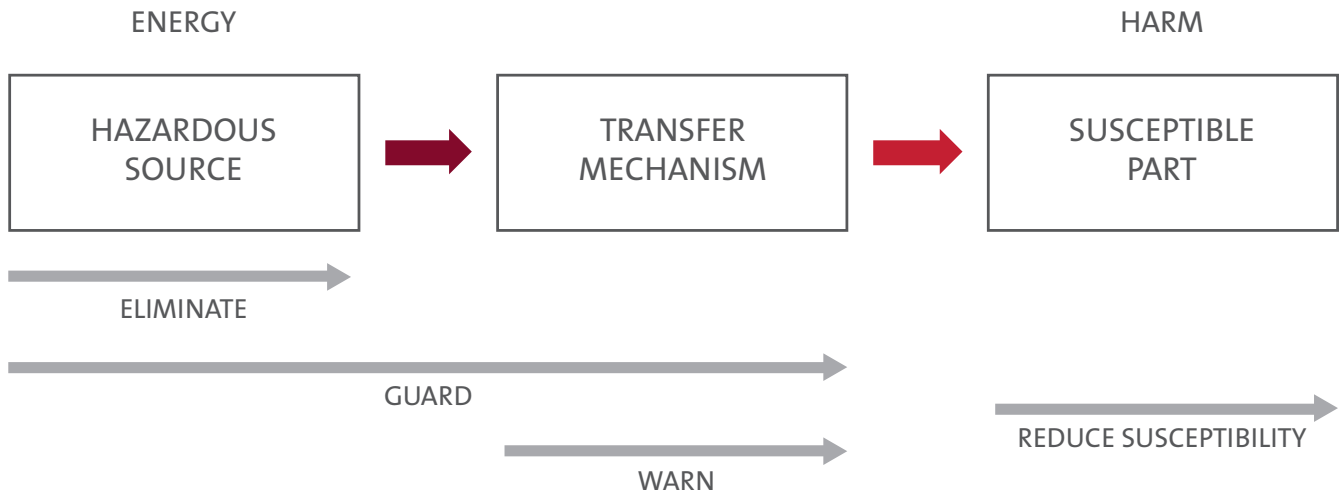
Figure 2: Hazard-based safety engineering conceptual diagram

that generates harm (injury) to the susceptible part (hand/finger) from the hazardous source (rotating blade). Though it is not being addressed in the current work, the diagram demonstrates how the first and most effective step is prevention of energy transfer or elimination of the hazardous source. Another possible strategy is guarding, preventing the transfer mechanism from acting on the susceptible part. For the hazard of a hand/finger coming in contact with a moving blade, reducing the susceptibility is one means of reducing the risk of serious harm.

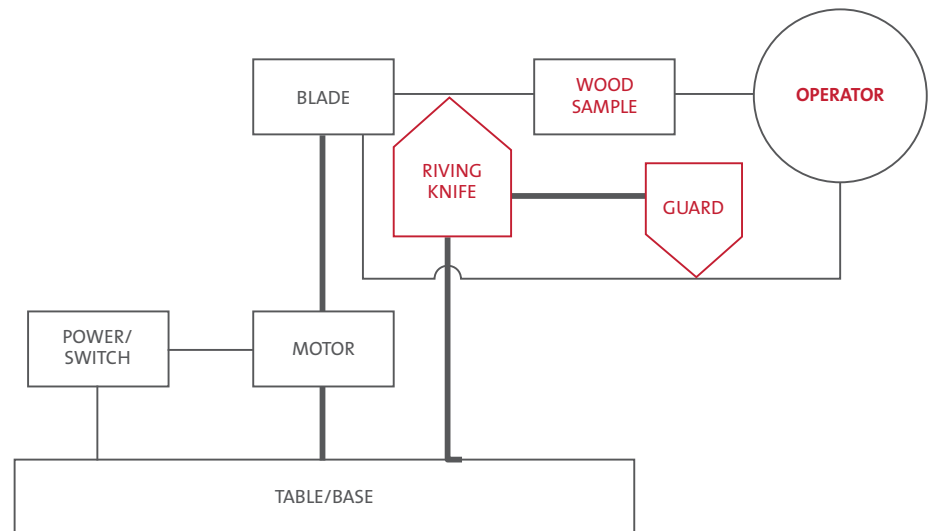
Figure 4: Simplified functional block diagram for generic table saw

The presence of a guard, required by UL 987, affords some protection against contact, mainly from the top, back and side of the blade. In the FBD, a solid line is shown directly connecting the operator to the blade, with the guard shown intervening in the middle (tip of the arrow labeled "Guard" in Figure 4). This graphic represents the role of the

guard in passively shielding the operator from contact injury with the blade in some circumstances. As noted in the CPSC study (Chowdhury & Paul, 2011), a guard was present in 34.3% of the cases involving blade contact injuries. This shows that, even with a guard present, based on current designs, blade contact injury is possible. However, since most blade contact injury cases cited in the CPSC study were with no guard present, the no-guard scenario is considered to be more comprehensive for the purposes of this hazard analysis.

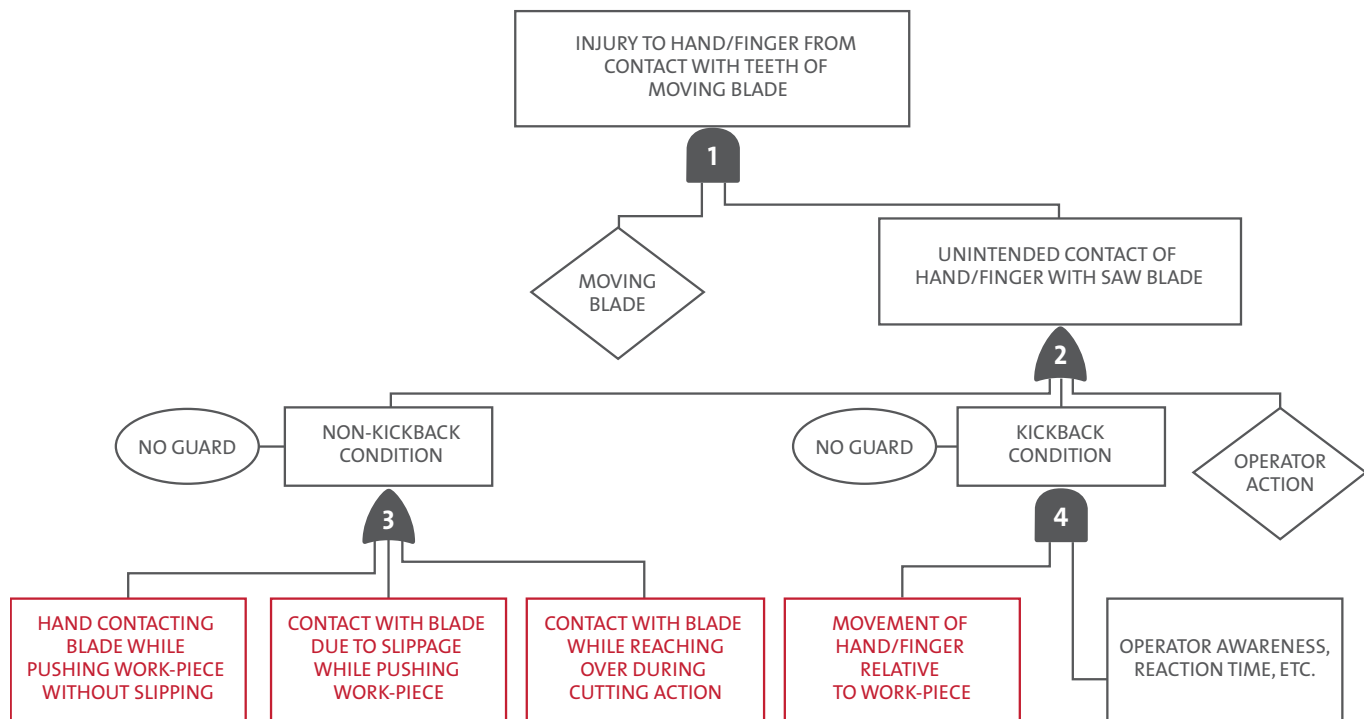
Figure 5: FTA of generic table saw with top-level hazard involving hand or finger blade contact injury

The building of the FTA starts with a high-level hazard: an injury from a hand/finger coming into contact with a moving blade (Figure 5). Below this top event is the first gate (an AND gate labeled as '1'), which requires that all items feeding into it from the immediate lower level of the fault tree occur for the high-level hazard to be realized. So, for a blade contact hand/finger injury to occur, both "unintended contact of hand/finger with saw blade" AND a "moving blade" are required. The 'moving blade' event is not developed further as it would not provide further insight into the injuries for these purposes. Of course, injuries can still occur with a stationary blade as noted in one of the incidents in Appendix B. Already, one can see the challenges in trying to capture circumstances that cover a wide range of ways in which the operator of a table saw could be injured through contact with a blade. One can always imagine a circumstance where an operator might slam his or her hand/fingers onto a stationary blade. The question that must continually be asked at each stage of the FTA is whether a circumstance would help inform the hazard analysis and not put undue requirements on safety systems for table saws. However, the other event under the AND gate 1, "unintended contact of hand/finger with saw blade", needs to be developed further to help capture the circumstances leading to the specified hazard.

The gate labeled 2 is an OR gate, and indicates that any one of the immediate lower events leading into it are sufficient for the event above it to occur. Therefore, the "unintended contact of hand/finger with saw blade" event could have one of three immediate causes. The first event, "operator action," leading into this gate could simply mean that the blade is rotating and, without any cutting of stock, the operator inadvertently brings his hand/finger in contact with the blade. Other researchers have looked into this issue and have cited reasons such as "being in a hurry, not realizing the hand was in a hazardous area, misjudging time and distance to avoid an injury, shifting work materials or tools and attention not fully on task" (Sorock et al., 2001) that would fall under this general event. This item will not be developed further as the analysis by the CPSC summarized in the introduction indicated that most injuries occur during cutting operations. It is also likely that some aspects of operator action will show up in other branches as the FTA is further developed.

The two other events, kickback and non-kickback conditions, describe two general categories that cover work-piece cutting operations when the hand/finger of the operator could come into contact with the blade. The choice of these categories was an attempt to develop a more tractable analysis. To list every conceivable way in which an operator could be coming into contact with a blade would create a very complex tree without necessarily improving the analysis outcome. One revelation when discussing the scenarios with the WG was the difficulty in describing a "representative" circumstance for blade contact injuries with high confidence. But this is not really surprising, considering how the state of the operator plays a large role in these incidents.

For the kickback and non-kickback events, there is an adjoining oval with the label "No Guard." This oval indicates that the event occurs under the conditions described in the oval. This simply reflects the scope of the analysis described earlier in this section. The kickback and non-kickback events are considered to be taking place without the presence of a guard.¹⁷

For the kickback condition, both "movement of hand/finger relative to the work-piece"¹⁸ that is being kicked back and (Gate 4) the "operator awareness of and reaction" to the sudden change in movement of the work-piece determine how fast the hand is moving and whether it contacts the blade. These events under the kickback condition are not developed further for reasons to be discussed in the Approach Speed Experiments section.

For the non-kickback condition, there are basically three general circumstances in which the hand/finger could contact the saw blade. First condition: an operator is pushing a work-piece into the blade during a cutting process, and it is possible that the operator is unaware of his/her hand moving very close to the blade until there is contact. Second condition: an operator is pushing a work-piece into the blade during a cutting process, and it is possible that the hand will slip and move toward the saw blade at a speed faster than the work-piece speed. Third condition: during a cutting operation, the operator is reaching over the saw blade and being distracted in the process so that a hand/finger comes into contact with the rotating saw blade. Notice in all conditions that operator awareness and reaction influence the motion of the hand/fingers.

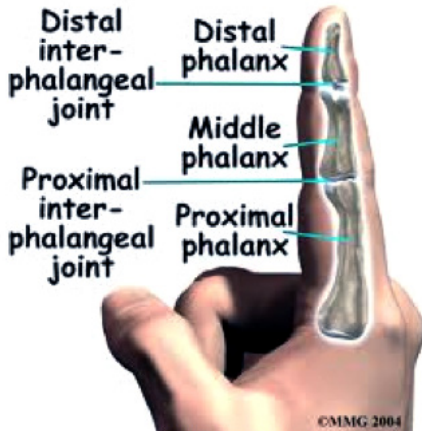
Figure 7: Internal structure of the finger

Table saw injuries can involve lacerations of varying depth in fingers, and owing to their distal location (Figure 6) and small size, fingers are especially prone to injury. Finger lacerations can be grouped according to structure damage: simple lacerations or complex lacerations, which include tendon, nerve or vascular involvement and amputation (Figure 7). Simple lacerations that damage only the epidermis and dermis can usually be treated at home with simple wound care, but may require emergency department attention. In either case,

simple lacerations generally heal uneventfully. The exception is fingertip lacerations associated with injury to the fingernail bed. Careful reconstruction must be undertaken to avoid fingernail bed scarring that can lead to painful or deformed finger nail regrowth. Deeper lacerations along the length of the finger disrupt more-vital structures. Severed tendons, nerves and, vessels require skilled microsurgery to ensure optimal functional and aesthetic results. Surgery may require a hospital stay and lengthy occupational therapy.

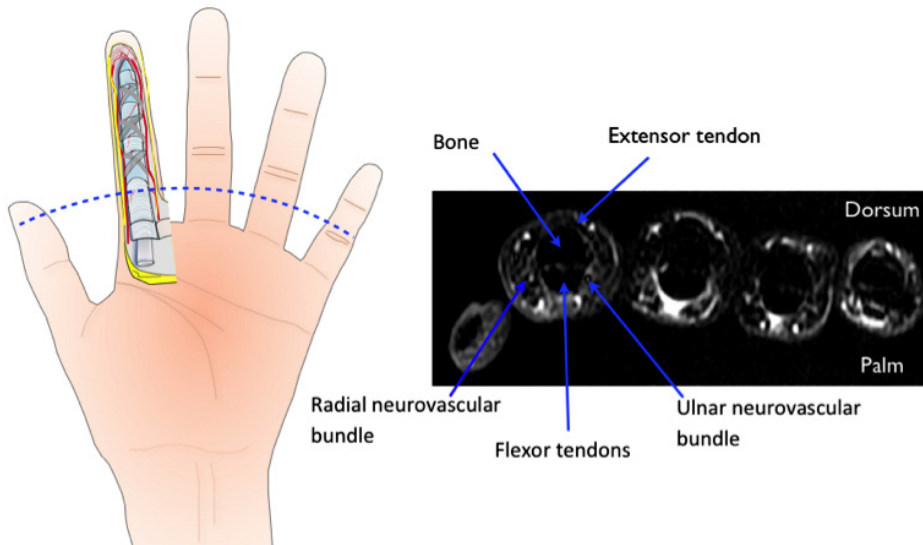
Because the depth of finger laceration has a direct effect on the structures injured, it is important to understand the depth of key anatomic structures relative to the skin's surface. In an extensive review of the literature, no sources were found providing anatomic measurements quantifying the relationship of vital structures in the fingers to the skin. Therefore, results were generated for this research by examining magnetic resonance imaging (MRI) scans from five patients from the Department of Surgery at the University of Michigan hand surgery practice who had undergone MRI scans for a hand condition unrelated to the fingers. Patients were selected for their similarity to the average sufferer of a table saw-related hand injury: middle-aged males (Becker et al., 1996; Shields et al., 2010; CPSC, 2011). Patients were male, with a mean age of 54 years (range: 42-74). MRI was of the dominant hand in two cases and of the nondominant hand in one case. In two cases hand dominance was not known. Using PACS radiology software, the distance from the surface of the skin to the neurovascular bundle, flexor tendon and bone was measured for each digit from both the radial and ulnar side. Measurements were taken at the midpoint of each phalanx (Figure 9) and the mean and standard deviation were calculated.

Figure 9: Sample MRI image of human fingers with anatomical structures labeled on the index finger

Generally, structures were deepest at the proximal phalanx of the long finger and most shallow at the distal phalanx of the little finger. The neurovascular bundle, which contains the nerves and arteries, is the structure closest to the skin's surface (Table 1). Its depth ranged from 4.3 mm at the distal phalanx of the little finger to 7.1 mm at the proximal phalanx of the index finger. Tendon depth ranged from 4.6 mm to 7.1 mm (Table 2), whereas bone was located at 6.3 mm to 13.5 mm (Table 3) in depth. Figure 10 shows graphically the meaning of these measurements based on data from one patient.

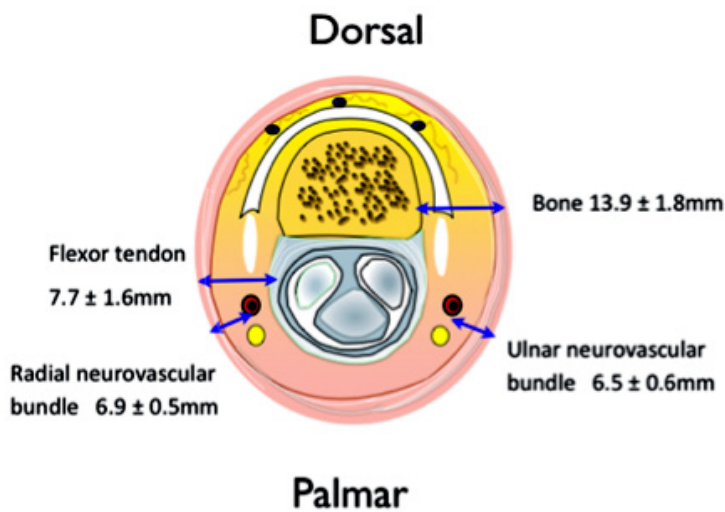
Figure 10: Cross section of the human index finger with anatomical structures labeled. Distances are from the skin's surface at the midpoint of the distal phalanx for a single patient (mean +/- standard deviation).

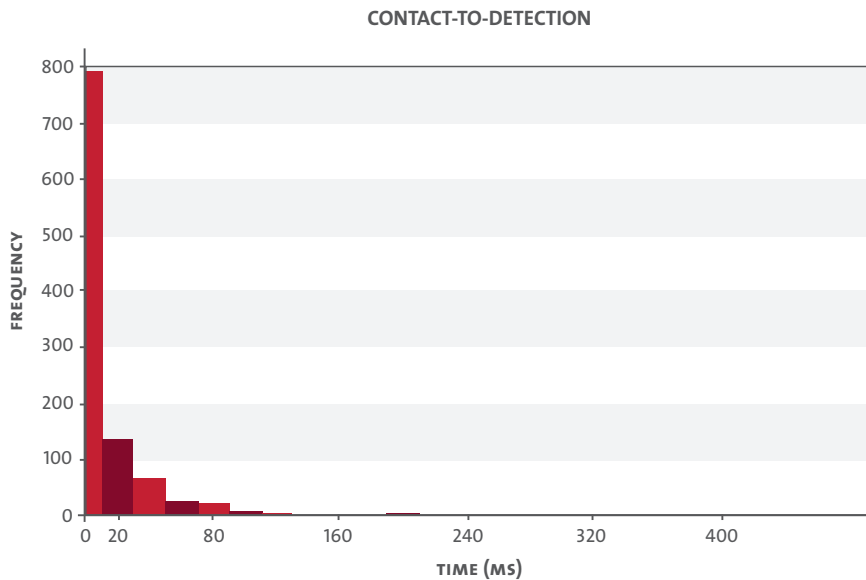
Figure 12: Histogram of contact-to-detection times of filtered SawStop customer injury database

defined by a 4mm depth of cut and that the "total time" for this system to remove the hazard is (1 ms + 3 ms) 4 ms, then the estimated hand approach speed would be 1 m/s (3.3 ft/s) for incidents involving SawStop customer injuries for the selected treatment categories.

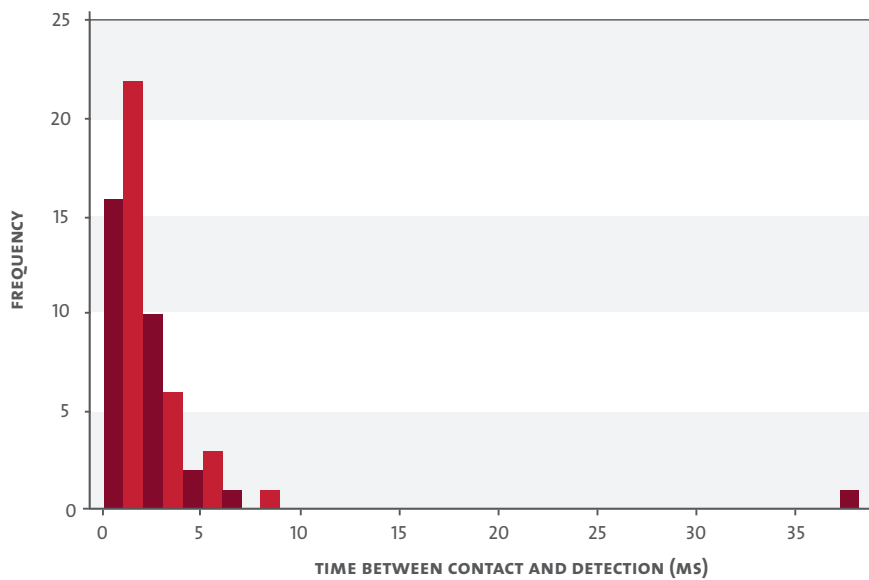
Figure 14: Histogram of time between contact and detection for the treatment categories 6, 7, 9 and 10

To develop the above analysis a bit further, consider treatment categories that might suggest a cut deeper than 4 mm. This would include categories 6, 7, 9 and 10. In these cases (69 entries), it may be possible that the cut extended up to the neurovascular bundle. Referring to Table 1, the possible depth of cut without damaging this bundle could be as high as 7 mm for the index finger, a finger that is typically injured. Figure 14 shows the time data for these selected treatment categories, and once again 1 ms is a fair estimate for "time between contact and detection". Assuming a "total time" of 4 ms and a depth of cut between 6-7 mm leads to estimated approach speeds in the range of 1.5-1.75 m/s (4.9-5.7 ft/s).²⁷

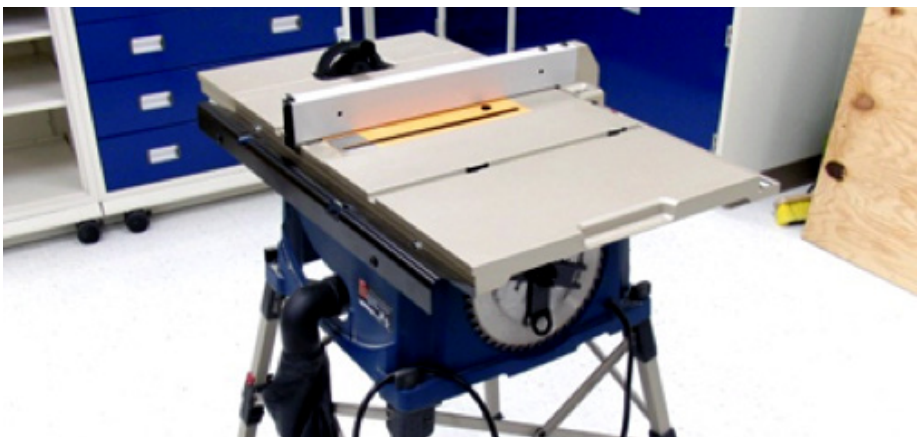
Figure 17: Photograph of direct-drive table saw used in experiments

The other table saw was a direct-drive design, was relatively light in weight and, although it had attached legs, could be considered a portable table saw (Figure 17). The motor label listed the following specifications: 120 V, 60 Hz, 15 A and 5,000 rpm (no load). This table saw was used to run the kickback experiments.

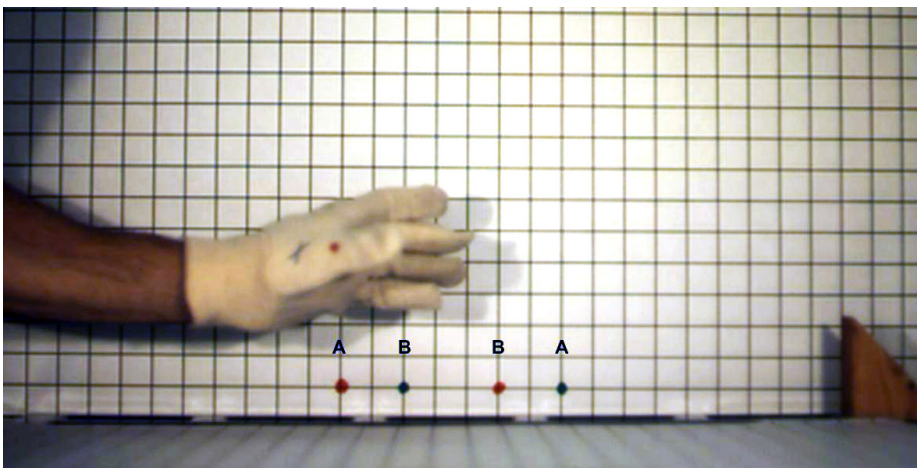
Figure 20: Photograph of one test subject during reach-over experiment

Results: For each test subject and each hand, the experiment was run three times. As participants were instructed to simply reach over and grab the piece of wood over a distance of 36 inches (0.91 m), it was noted that some subjects

were clearly attempting to go as fast as possible though no such instruction was given. From these experiments, the overall average velocity for the 12 participants was 12.7 ft/s (3.87 m/s) for position A (leading edge of the blade) and 13.8 ft/s (4.21 m/s) for position B (middle of the blade).³¹ This suggests that the hand was still accelerating as it passed the leading edge of the blade. The maximum speed was 22.9 ft/s (6.98 m/s) for position A and 24.9 ft/s (7.59 m/s) for position B. The minimum speed was 8.2 ft/s (2.5 m/s) for position A and 8.5 ft/s (2.59 m/s) for position B. Though the minimum speeds cited were for two different test subjects, the maximum speed for both positions was achieved from the same test subject. Table 4 and Table 5 show individual measurements calculated for the 12 test subjects.

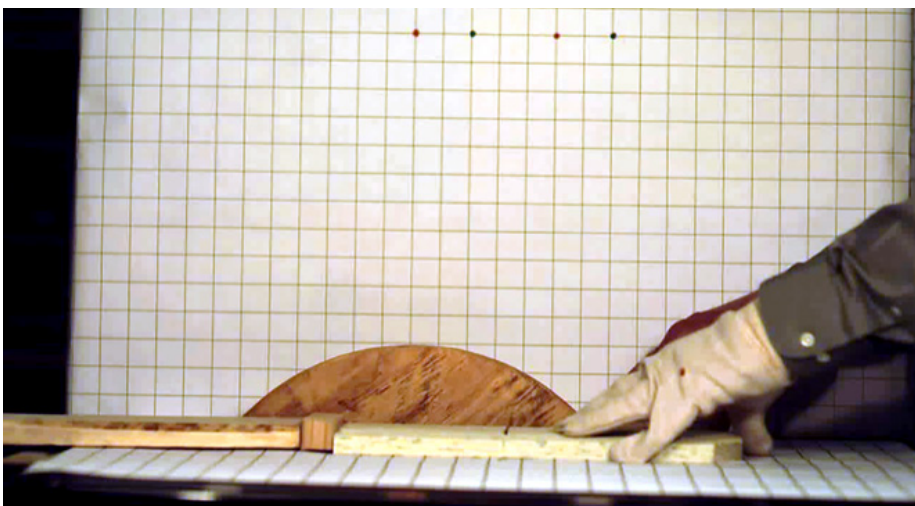
Figure 21: Reach-over test with falling board (left-most piece)

Procedure: In order to create an experimental condition closer to what was described in the narratives, a variation on the previous reach-over test was developed. For these experimental runs, the test subject was asked to push a piece of wood (representing a work-piece) in parallel to a surrogate blade (Figure 21) with both hands. This work-piece, in turn, pressed against another separate piece of board (representing the cut work-piece) which would at some point begin to tip over the end of the table top. The test subject was instructed to push the work-piece, mimicking the action of an operator cutting a board and, upon noticing the second piece of board tipping over, to reach over and grab it.

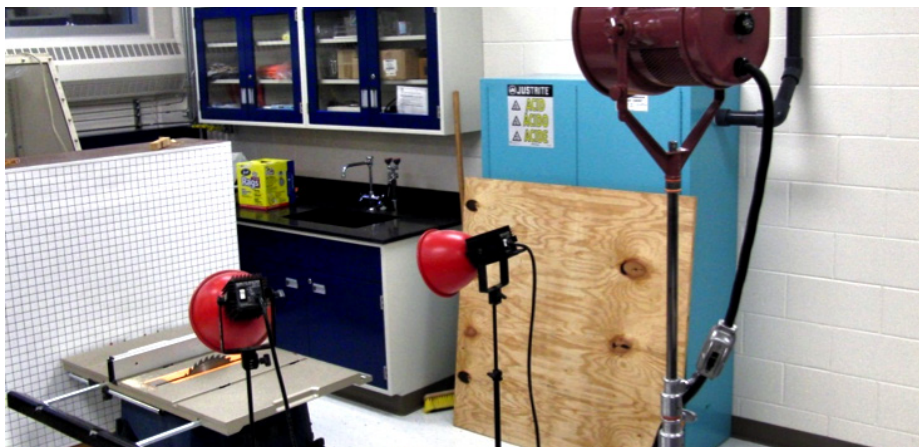
Figure 22: Experimental setup for kickback simulations

Results: The first method for the rip-cut experiments did not generate a kickback condition. The second method did produce kickback with speeds ranging from 17 to 27 ft/s (5.18 to 8.22 m/s). Calculating the speed of the work-piece during kickback was challenging. The motion of the work-piece was not a simple in-plane motion but rather a combined in-plane and out-of-plane motion. To properly³⁴ identify the different components of velocity, three points on the work-piece were used. For the cross-cut experiments (Figure 24) the calculated work-piece speeds for the different components ranged from 26 to 80 ft/s (7.92 to 24.4 m/s).

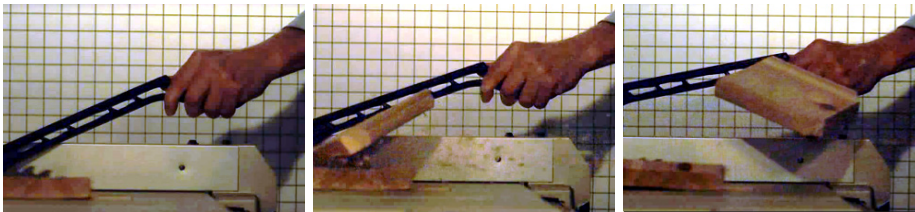
Figure 24: Kickback during cross-cut experiment at different time frames starting from the left-most image.
